04.01.2016 / ThMe

Inspection notice BEAMTAC (Art. No. AP-017, Batch No. 225376 to 254052)

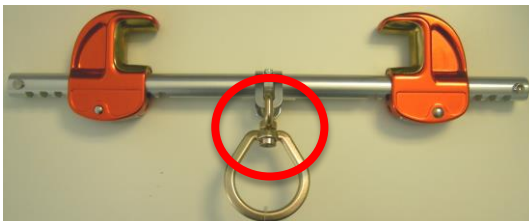
Image 1

1. Inspect the swivel D-Ring on the BEAMTAC for any signs that the compression nut has started to unscrew (See Images 1 & 2). The compression nut and bolt should be approx. level and the D-Ring fixed in a position that prevents it moving vertically up and down.

The design of the BEAMTAC, designed and manufactured by ClimbTech, could have a reduced life span when used extensively, especially when permanently under suspension, e. g. rope access.

In one case SKYLOTEC was advised of an incident from one of our customers. The compression nut came away while the customer was working. The customer, an experienced rope access technician, has been caught by his back-up without injuries. The loosening of the nut has neither been detected during usage nor at the inspection before each use. Depending on the devices clean condition the loosening of the nut is not evidently visible.

2. If your inspection indicates the compression nut has started to unscrew and/or the D-Ring can be moved vertically up and down, the BEAMTAC'S life span has been reached and the product must be removed from service
3. If the compression nut and the bolt are still at the same level, mark the position of the nut at the shaft by using red varnish marker (Image 3) to make the next inspection easier and record the information into the inspection log. This process will make it more obvious if the compression nut is starting to loosen by slow rotation which will be shown in the displacement of one half of the red marking.
4. If varnish marker is needed please contact SKYLOTEC by sending the batch number and amount of your BEAMTACs to RaKr@skylotec.de

To extend the life span of the swivel at the BEAMTAC the manufacturer ClimbTech has committed to a more secure fixing of the compression nut with the bolt. **The improved version will be implemented from SKYLOTEC batch number 255937 which is marked at the side of one of the flange hooks.**
