04.01.2016 / ThMe

Inspection notice BEAMTAC (Art. No. AP-017, Batch No. 225376 to 254052)

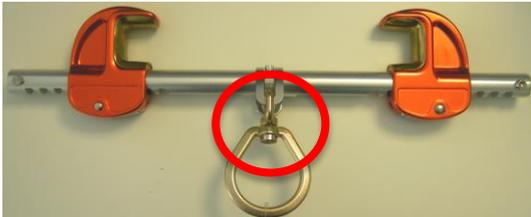
Image 1

1. Inspect the swivel D-Ring on the BEAMTAC for any signs that the compression nut has started to unscrew (See Images 1 & 2). The compression nut and bolt should be approx. level and the D-Ring fixed in a position that prevents it moving vertically up and down.

The design of the BEAMTAC, designed and manufactured by ClimbTech, could have a reduced life span when used extensively, especially when permanently under suspension, e. g. rope access.

In one case SKYLOTEC was advised of an incident from one of our customers. The compression nut came away while the customer was working. The customer, an experienced rope access technician, has been caught by his back-up without injuries. The loosening of the nut has neither been detected during usage nor at the inspection before each use. Depending on the devices clean condition the loosening of the nut is not evidently visible.

2. If your inspection indicates the compression nut has started to unscrew and/or the D-Ring can be moved vertically up and down, the BEAMTAC'S life span has been reached and the product must be removed from service
3. If the compression nut and the bolt are still at the same level, mark the position of the nut at the shaft by using red varnish marker (Image 3) to make the next inspection easier and record the information into the inspection log. This process will make it more obvious if the compression nut is starting to loosen by slow rotation which will be shown in the displacement of one half of the red marking.
4. If varnish marker is needed please contact SKYLOTEC by sending the batch number and amount of your BEAMTACs to RaKr@skylotec.de
